Yin, X, Lawrence, M, Maskell, D & Chang, WS 2018, 'Construction and monitoring of experimental straw bale building in northeast China', *Construction and Building Materials*, vol. 183, pp. 46-57.
<https://doi.org/10.1016/j.conbuildmat.2018.05.283>

Construction and monitoring of experimental straw bale building in northeast China

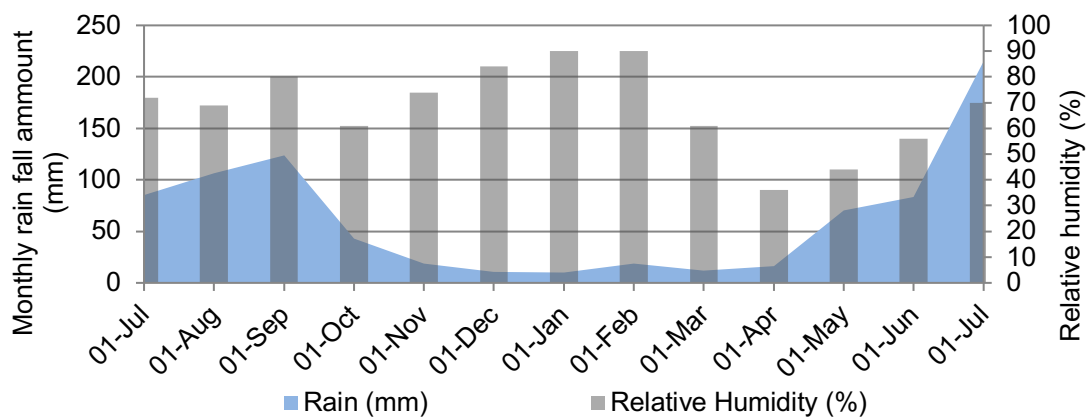
Figure 1. Average monthly Humidity and rain fall in Changchun from July 2016 to June 2017. (21)

The experimental straw bale house was constructed in Changchun, in the Jilin province of northeast China. The area is subject to a typical temperate monsoon climate. Temperature peaks at around 30°C in summer in the area and drops to below freezing after late October annually (21). The highest monthly air humidity level is 88% in January (Figure 1), where monthly humidity levels are from 63% to 72% in summer during which the highest temperature appears.

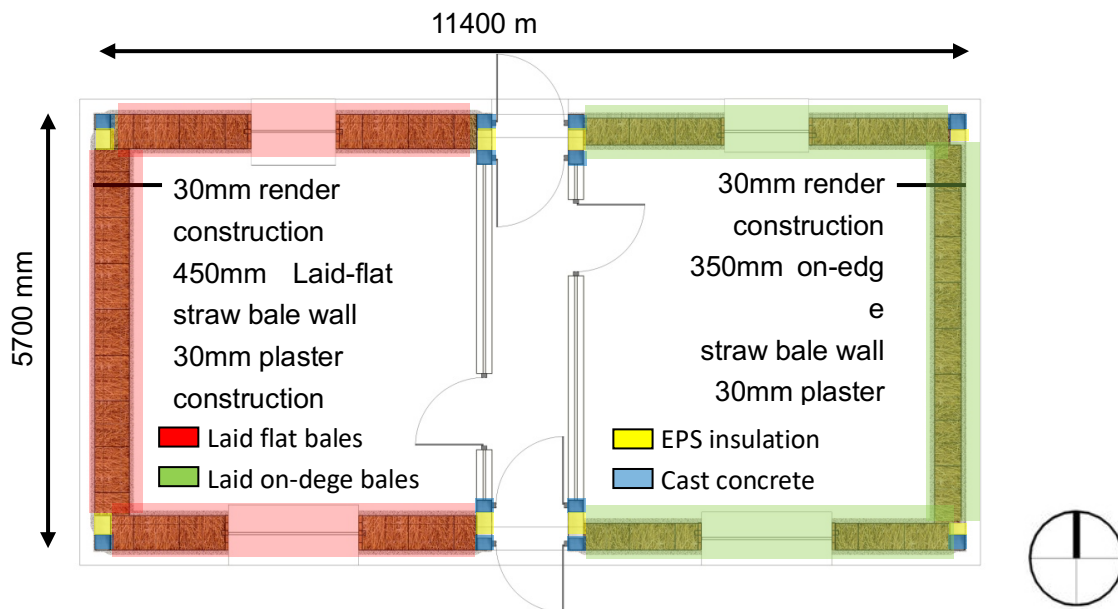
Figure 2. Floor plan and applied bale stacking.

The experimental building is a single story bungalow with pitched roof. The structure and foundation is made of cast concrete, being the construction technique with which the builders used in this project are familiar. Both laid-flat stacking and laid-on-edge stacking of straw bales are applied in the construction (Figure 2). A section of north facing wall with laid-flat straw bale is left unplastered on the interior surface of the wall and wood frames are used to create a truth window which only shows the straw bales. The truth window is designed on the mid height of the wall to visually examine straw degradations.

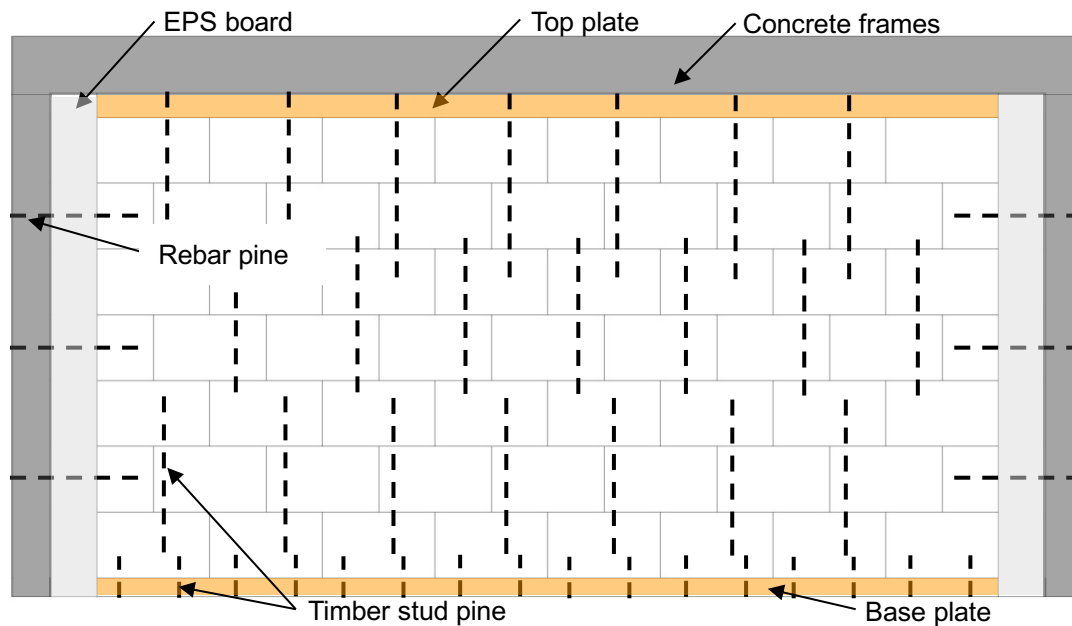
Figure 3. Pinning system of the experimental straw bale building.

The experimental building introduces a pinning system in the construction. The pinning system uses pointed timber dowels to connect each bale. Connections between bales

are referenced from Jones (9) and Myhrman & MacDonald (2). The pinning system introduces horizontal pins to fix the bale walls to columns. The horizontal pins are made of edged rebar and they are passed through preformed holes within the concrete columns. The horizontal rebar pins can increase buildability and stability of the bale walls during construction (Figure 3).

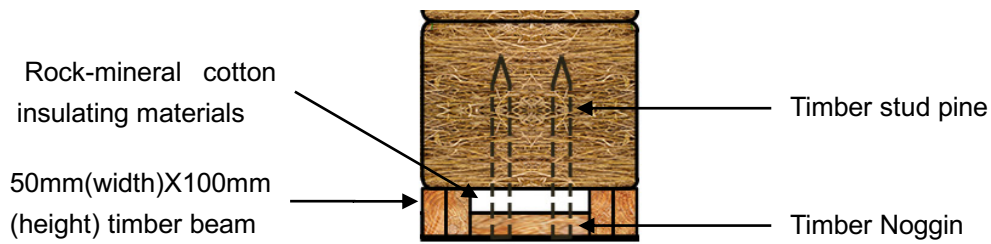
Figure 4. Toe-up base plat and timber rods

The toe-up construction used is a variation of the typical timber base plate structure which is designed by Jones (24). The base plates in the construction contain 100mm x 50mm toe-up timber beam, timber noggin between the beams, timber stud pin and thermal insulation materials (Figure 4). The timber stud pins are used to replace hazel rod in the Jones's system (24) because of poor availability of hazel in north China. Because the industrial timber studs have round and smooth surface, each timber noggin contained two holes for pins to provide sufficient fixing to the bales.

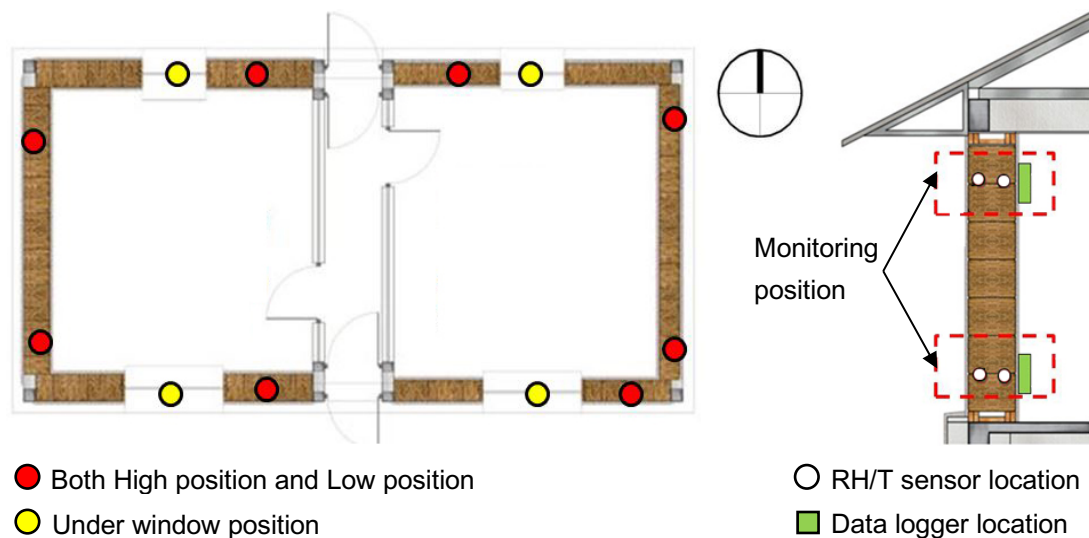
Figure 5. Floor plan (left) and walling section (right) with sensor location

Total 20 sensor locations are designed to provide monitoring data inside every façade of the building. The placements of sensors was designed to monitor the most problematic areas for straw degradation seen in similar climatic regions in Japan(25) and Canada (15). The sensors are installed beneath the top bales, on the top of bottom bales and beneath the bale under the window sill on the south facing walls and north facing walls (Figure 5). Each location has two sensors in different depth in straw bale wall. The sensors were placed at a depth of 100mm below the external surface and internal surface of straw bale walls. The monitoring results were compared by examining the actual vapour pressure within walls and the duration of periods where humidity exceeded 85% RH.

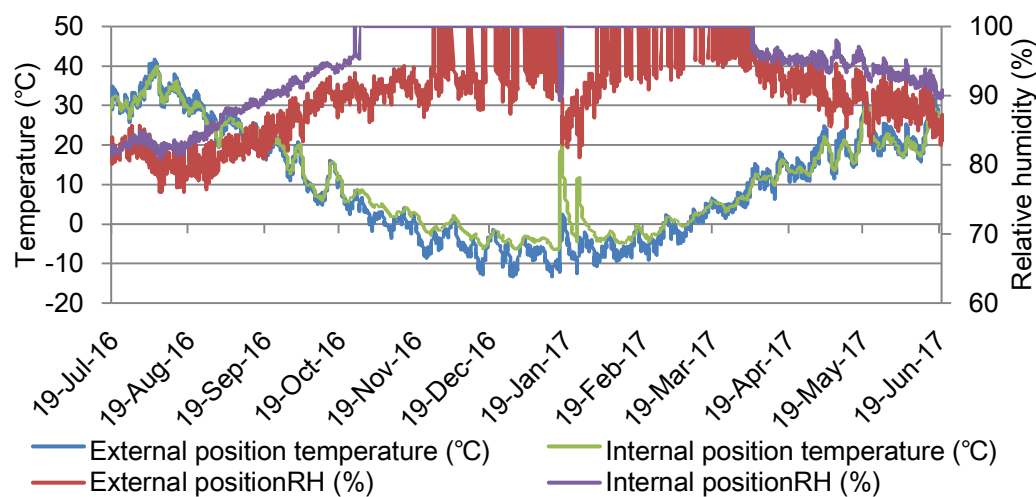
Figure 6. Monitoring data of the high position of north facing wall with laid flat bales

The monitoring data showed high RH at the beginning of the monitoring period. The RH readings remained at 100% RH on all faces of the experimental building over the winter period, reducing in spring-time. Typical trends of the monitoring data can be taken from the high position of north facing wall with laid flat bales (Figure 6).

The monitored temperature of the position increased initially and peaked around two weeks after the monitoring began. The highest monitored temperature is 44.8 °C at the position under the window of the south face of the on-edge stacking wall. The monitored temperatures remained consistently below freezing point from around the beginning of November and the monitored temperature stayed below 0°C until March of the following year. The lowest monitored temperature is -14.7 °C and it appeared under the window position of the north face of the on-edge stacking wall on 29th December 2016. The onsite visit had an impact on the monitored data from 16th

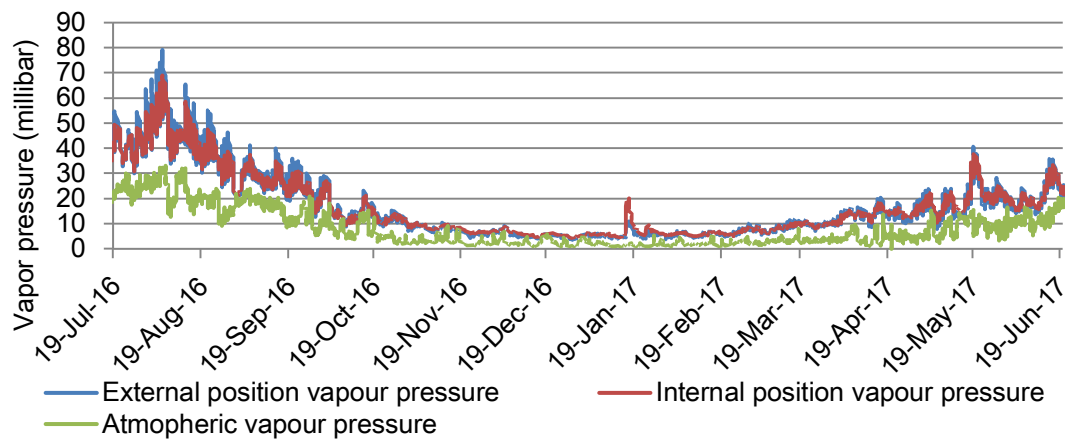
Figure 7. Vapour pressure of sensor locations (down) within low position of the south face of on-edge stacking straw bale wall.

The monitored RH/T data is a guide to the hygrothermal environment within straw bale walls. However, it is difficult to predict either actual water content inside straw bale walls or vapor movement between straw bale walls and external environment. The vapour pressure of all monitored positions kept increasing to highest level two weeks after the beginning of the monitoring period. The highest vapour pressure levels were around 76-77 millibars and they appear in external sensor locations of low positions on south facing walls (Figure 7). Other than the low positions on south facing walls, the peak vapor pressures of the monitoring positions are all below 70 millibars. After initial increase of vapour pressure in all the monitoring positions, the vapour pressure levels decreased in the following months and rise again after January 2017.

walls. However, due to unreliable RH/T data from December to January, the actual vapour pressure data of all monitoring positions are not accurate during the period of time. A demonstration of the unreliable vapour pressure data is the significant increase of vapour pressure data during heating process during the on-site visit from 17th January 2017 to 19th January. At the end of the monitoring period, sensor locations within south wall have lowest vapour pressure data than the ones within other faces of wall.

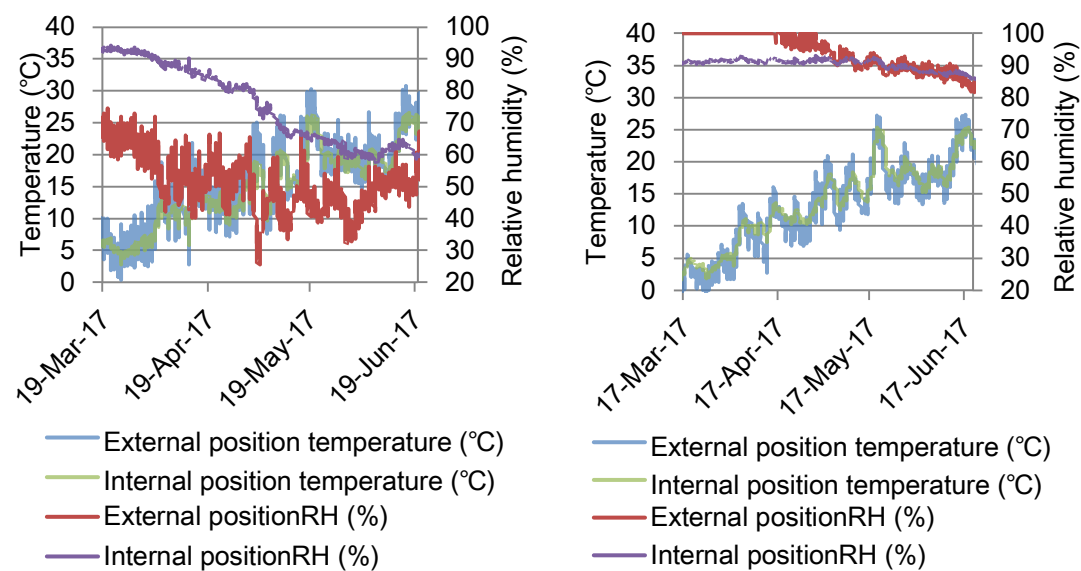
Figure 8. Monitoring data of the low position of the south facing wall with laid flat bales (left) and the low position of the north facing wall with laid flat bales (right).

The monitoring data at different positions show that the building orientation has a marked impact on the RH distribution within different faces of straw bale walls. The monitoring positions recorded lower RH levels in the south facing walls than the positions in other wall elevations. The lowest recorded RH level is 26% at the low position of the south face of laid-flat stacking straw bale wall on 4th May 2017 (Figure 9). The RH levels of the monitored location increase and fluctuate between 50% RH and 60% RH in June 2017. In comparison with the low position of north facing wall with the same infill stacking method of bales, the RH data fluctuate from 93% to 81% (Figure 8). The driving wind could speed up drying process of external render and results in lower RH levels of south facing walls than other facing walls.

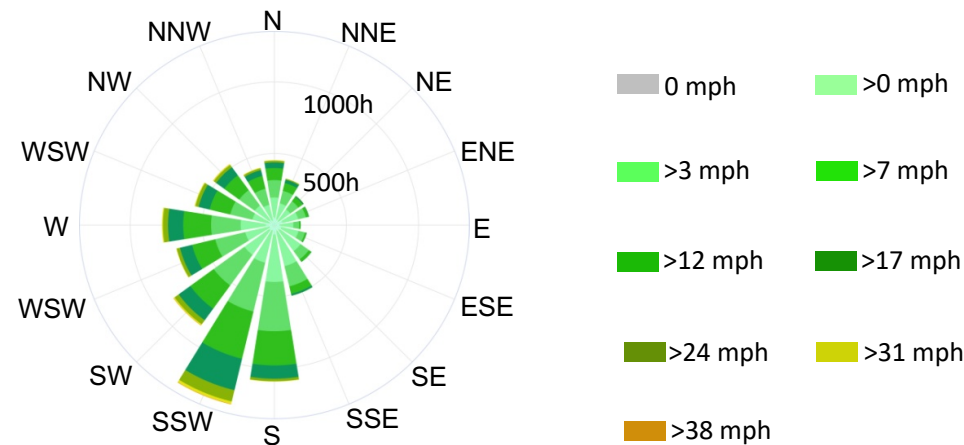
Figure 9. Annual wind intensity plot of Changchun. (27)

The yearly data of wind direction and wind speed suggest that the wind is stronger and more rapid from south and south-west (27) than north and east of the building (Figure 9). Due to the wind comes from south face of the building; the lowest wind velocity would be outside north face of walls. As a result, the north face of walls may not have sufficient driving wind to dry the lime rendering. Comparing to the north facing walls and the east gable wall, the north facing walls have slower sufficient driving wind for drying the walls due to the dominating wind in the winter time is northerly (28). During that time, the temperature is lower than freezing point and vapour is likely to become ice during the time. The wind may not significantly take vapour from north face walls.

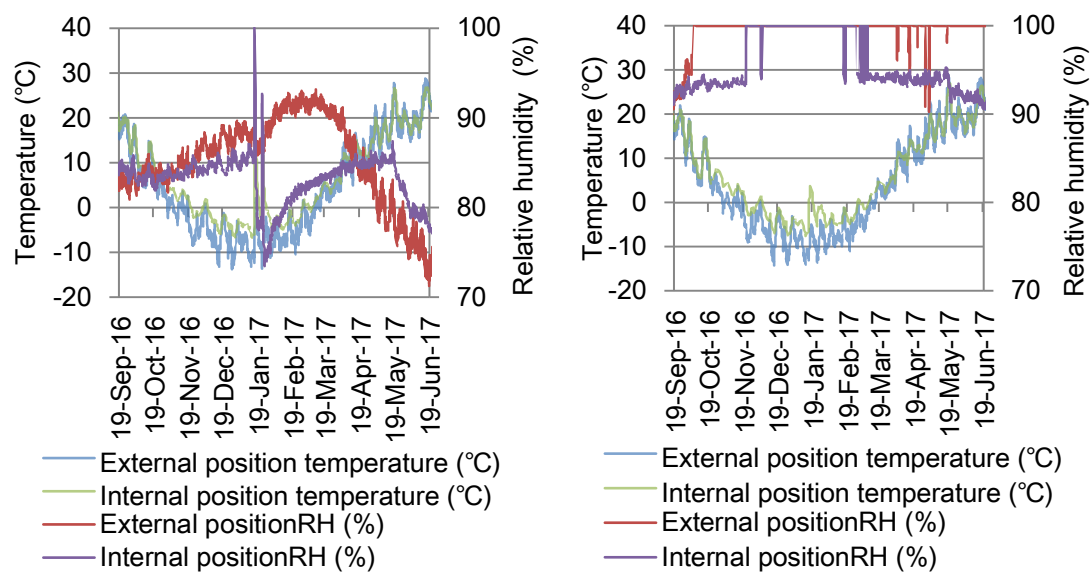
Figure 10. Monitoring RH/T data of low position (left) and under window position (right) of north facing wall with laid flat bales.

The comparison of the monitoring data of low positions and under window positions of the same piece of wall can justify the RH distribution at similar height with different building constructions in the wall. To minimize the influence of solar radiation on the monitoring data, the analysis focuses on the north facing wall. In comparison with the monitoring data of the low position and the under window position of north facing wall

with laid flat bales, the RH reading of the low position are more than 10% of RH lower than the under window position from 19th/September2016 during the monitoring research (Figure 10). Due to the temperature of the two monitoring positions, the monitoring data show less vapour pressure at the low position than the under window position and therefore the straw bales contain less moisture around the low position than the one around the under window position.

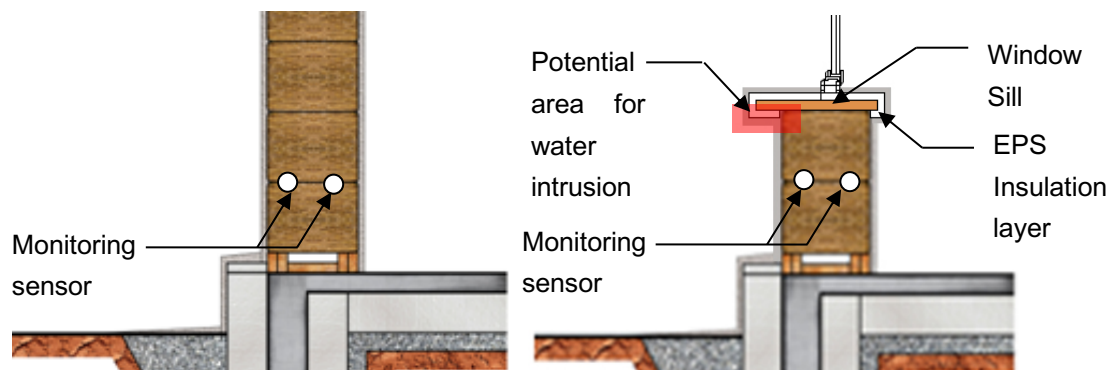
Figure 11. Walling construction of the straight walling (left) and the walling around window opening (right)

The different walling construction detailing of the two monitoring positions may be the reason of the different RH distribution during the monitoring period. The constructions of the under window areas of straw bale walls connect window sill and the insulation layers of the window sill and such constructions involve more detailing construction than the straight walls (Figure 11). The increased construction detailing of walls increase the potentials of issues of construction quality and leakage. The monitoring data in this research show notable higher moisture content of the bales at the location below window sills, care should be taken in improving quality control of the construction in further construction. Further research would focus on the methods and detailing designs for minimizing the issues of walling construction identified in this research.

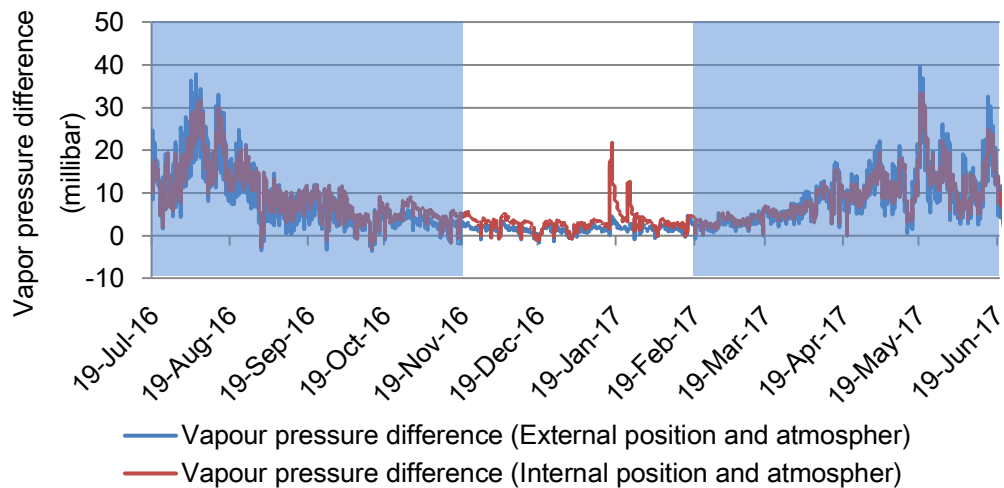
Figure 12. Vapour pressure difference of the northern high position of the west gable wall

The vapour pressure difference between the monitoring positions and the atmosphere can describe the moisture movement trends between the straw bale walls and the atmosphere. Higher vapour pressure data of the monitoring positions than the atmosphere indicate that the straw bale walls release moisture into atmosphere at the data collecting point and vice versa. Fully dried straw bale walls will establish moisture exchange between straw bales and external atmosphere and the fluctuation of the vapour pressure difference is an indication of fully dried straw bale wall. Constant higher vapour pressure data of the monitoring position than of the atmosphere are highlighted in blue to indicate unfinished drying process; the fluctuations of the moisture difference around 0 are the sign of fully dried walls and the periods of time are labelled in green (Figure 12 & Figure 13 & Figure 14). Considering unreliable monitoring data during winter months in the monitoring period, the monitoring data are analysed in two period of time in this research. The first period begins at the beginning of the monitoring research and ends at 1:00 am 19th November 2016. The second period is from 1:00am 19th February to the end of the monitoring research.

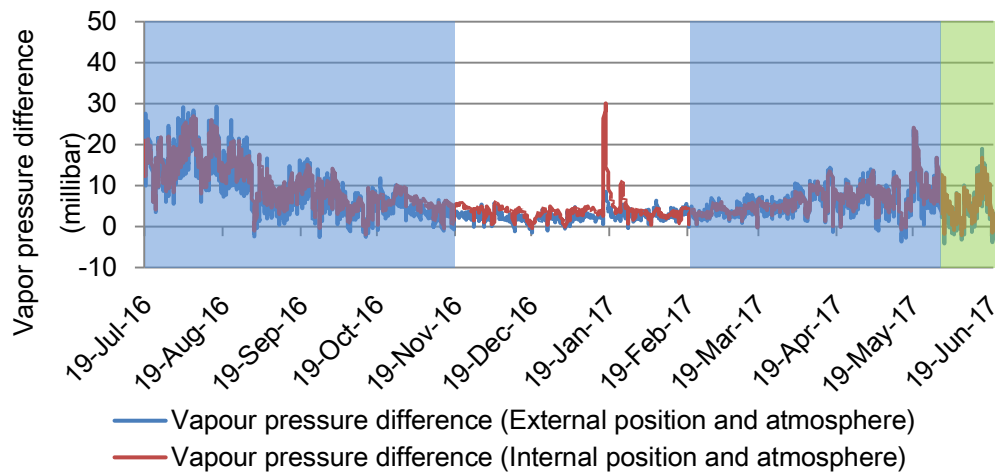
Figure 13. Vapour pressure of sensor locations of the low position of the south facing wall with laid on-edge bales

The comparison of the vapour pressure difference data of the laid-flat bale walls and the laid on-edge bale walls show that the method of bale stacking has notable impact on the drying process of the straw bale buildings in northern China. The south facing wall with laid-flat bales were complete dried after the first drying months and established moisture exchange with atmosphere after half year of the monitoring process. The south facing wall with laid on-edge bales experienced longer drying process than the laid-flat walls and it fully dried after April 2017.

Compared with on-edge stacking bale wall, the laid-flat bale wall have greater vapour pressure gradient between the exterior sensor location and the atmosphere than the one located in the same sensor location in the laid on-edge bales (Figure 18 & Figure 19) during the first period of the analysis. Due to the drying process of the walling constructions is not finished during the period of time; the higher gradient indicates that the laid-flat bales adsorb more moisture from rendering construction than the laid on-edge bales. A hypothetical theory for explaining the situation is that the moisture adsorption and desorption process of straw bales is mainly through the cross section of straw. Therefore the straw bales with laid-flat stacking method adsorb more moisture than the laid-on edge bales during the drying process of rendering construction. For the same reason the laid-flat bales have quicker response to low air humidity levels in dry months and result in faster drying process of the laid-flat bales within the south facing walls. The hypothesis of adsorption and desorption process of straw need to be analysed in further research.

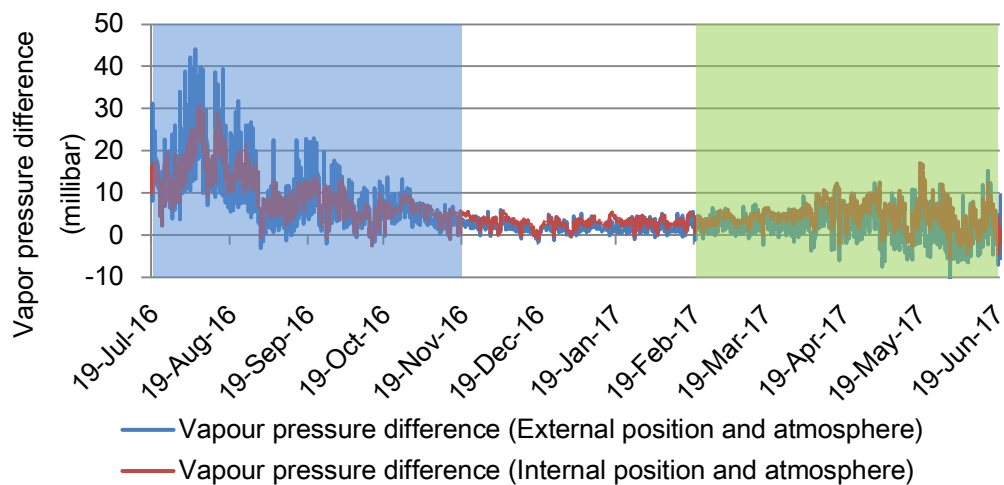
Figure 14. Vapour pressure of sensor locations of the low position of the south facing wall with laid flat bales

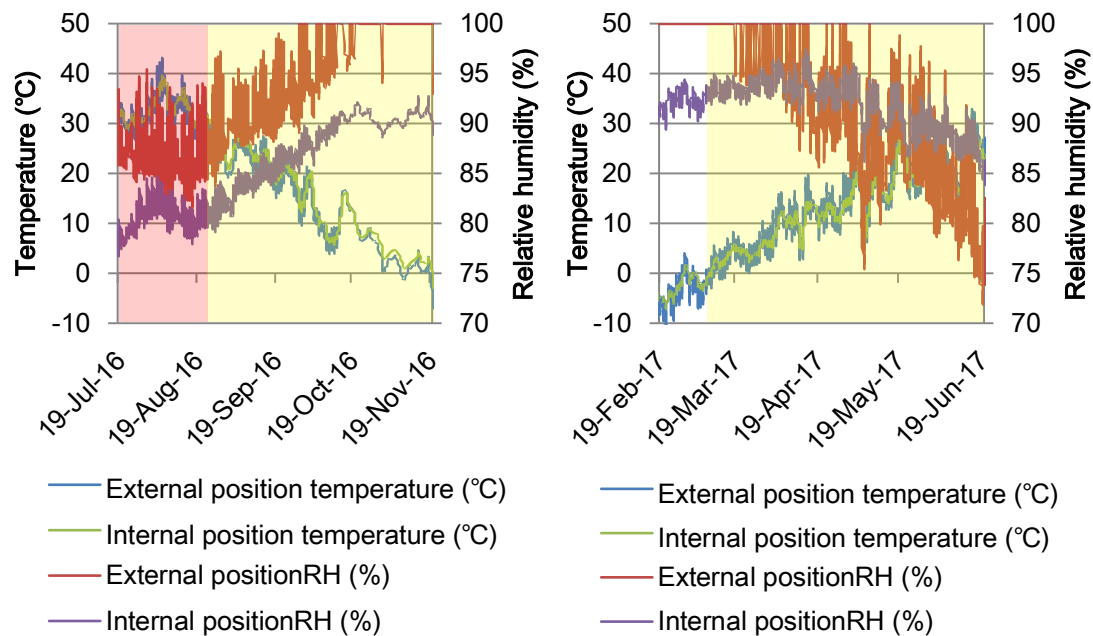
Figure 15. RH/T data before winter months (left) and after winter months (right)

The monitoring data are compared with the potential degradation level of RH (85%). As microorganisms cannot survive without presence of liquid water, the degradation potential is not examined when monitoring temperature is lower than freezing point in winter months (19). The RH levels are measured as being constantly higher than 85% within all straw bale walls during the monitoring period and therefore the period of potential degradation is determined by the periods when temperature remains consistently above 0°C. The yellow rectangle in Figure 15 shows the period of time for supporting straw degradation during the monitoring research. The straw within walls also experienced high temperature and high humidity situations (over 30°C and over 85% RH) in which straw would experience serious degradation. The period of time is around 1.5 months and it is shown in red rectangle in Figure 15. Such long period of

hot humid environment within straw bale walls has been few reported in other research papers. This period of time may have potential to lead to serious degradation of straw bales within walls initially after the completion of the experimental straw bale building.

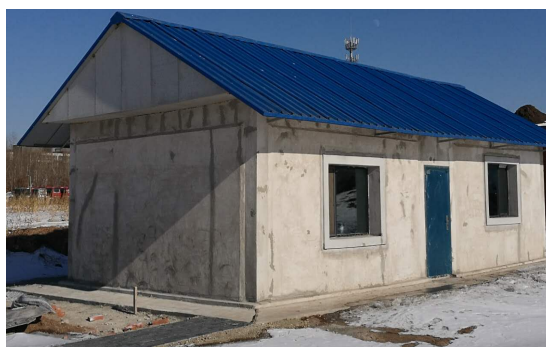
Figure 16. The lime render in this research during the first site visit

During both on-site visits to the experimental straw bale building, the rendering construction straw bale walls were found to be in good condition. Comparing with the condition after construction, there is no notable change to the walls. The lime render withstood low winter temperature of the area and there is no noticeable cracking after the initial drying process of the outer layer of the lime render. A comparison of the lime render in this research and the cement render in the ADRA project demonstrates that the lime render would be a more suitable rendering material (Figure 16).

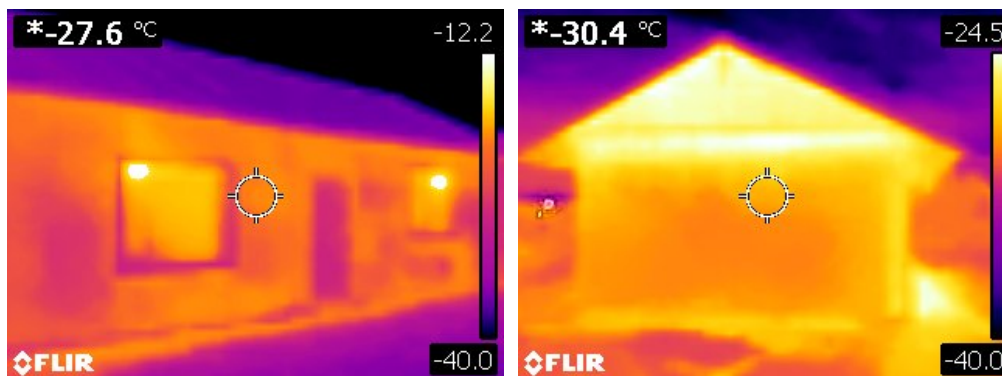
Figure 17. Thermal image of south wall (left) and west gable end wall (right).

The infrared image of the straw bale buildings also suggests that there is no significant thermal bridging through the straw bale walls (Figure 17). The surface temperature of

the gable end wall with infill straw bale has lower surface temperature than the PVC insulated columns. If the straw had undergone serious degradation before the onsite visit, the thermal image would present thermal bridging caused by hollows within the walls. The thermal bridging free straw bale wall suggests that the straw within the walls remained in good condition and there is no significant degradation within the walls.

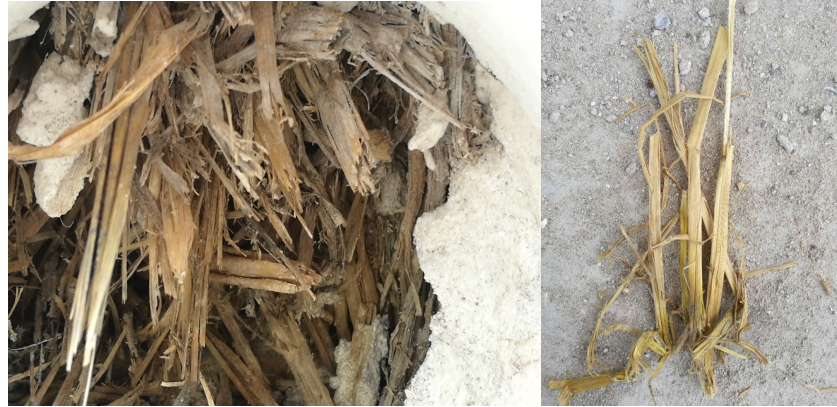
Figure 18. Opening of external render (left) and straw adjacent rendering layer (right)

To examine the straw condition behind rendering layer, several positions of rendering layer were removed to expose the straw inside the bale walls (Figure 18). There was found to be limited degradation of straw at the interface between straw bales and external rendering. Decolourization appears 1-2 cm deep into the straw. Straw remain golden colour inside the walls. The site visit confirms that the straw is in good condition in the straw bale walls. The degradation only appears on the interface between straw bales and the rendering layer. The degradation may be associated with the long drying

process of the straw bale walls and the resultant condensation at the interface between straw bale and rendering.
